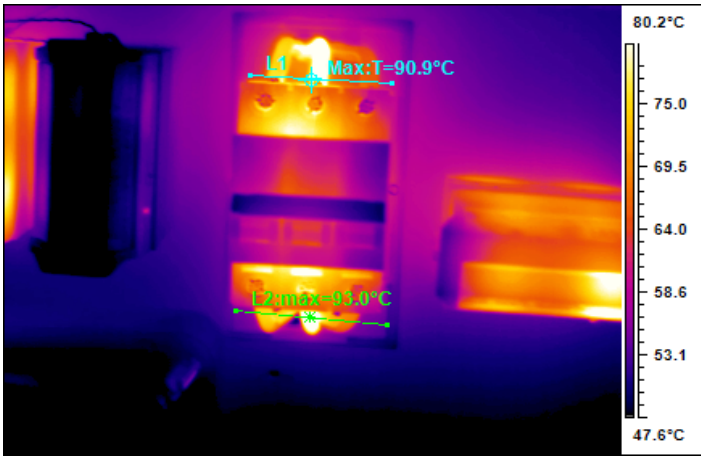
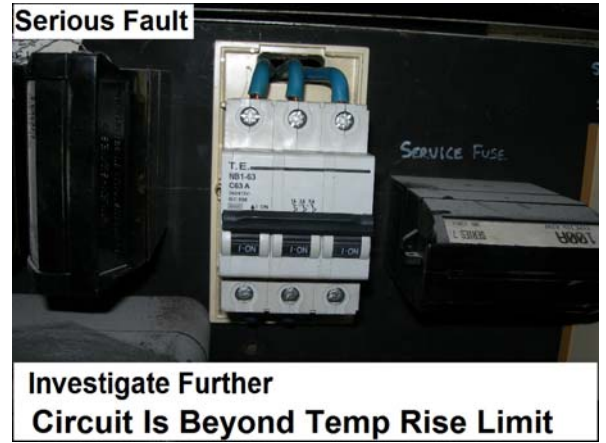
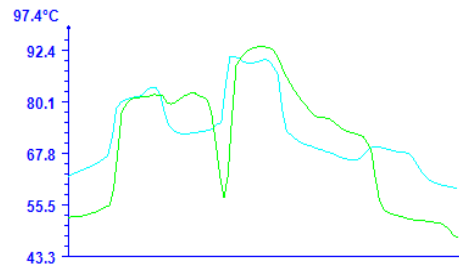
Infrared Image IR005491.JPG

Asset	34 XXX St, Parramatta
Location	Level 1
Switchboard Name	Meter Section
Equipment	63 Amp 3Ø Miniature Circuit Breaker (MCB) – CB Sub Main Control for Ground Level Cafe
Fault Description	Possibly a Termination Fault, but more likely to be an overload. See Note below.
Working Conditions	Normal
Background Temp	24.9°C
Distance	3.0m
Create Time	Thursday, April 15, 2010

Object Parameter	Value
Max	90.9°C
L1:AvgTemp	74.5°C
L1:MaxTemp	90.6°C
L1:MinTemp	59.5°C
L2:AvgTemp	72.5°C
L2:MaxTemp	93.0°C
L2:MinTemp	47.9°C

<b>Fault Rating</b>	<b>Serious Fault - High</b>
<b>Recommendation or Comment</b>	<p>Repair in 2 to 3 weeks. <b>Circuitry appears to be overloaded. Circuit may need upgrading.</b></p> <p>Current was not measured due to space restrictions, so a full assessment could not be reached.</p> <p>If current exceeds MCB rated capacity – replace MCB and reassess.</p> <p>If current is less than 63 amps then re-terminate both line and load side and reassess.</p> <p><b>Note:</b> Oxidation and arcing damage may have occurred at these temperatures. If oxidation and arcing damage cannot be corrected, parts and cable should be replaced.</p> <p><b>Note: Equipment is beyond recommended temperature rise limits.</b></p>

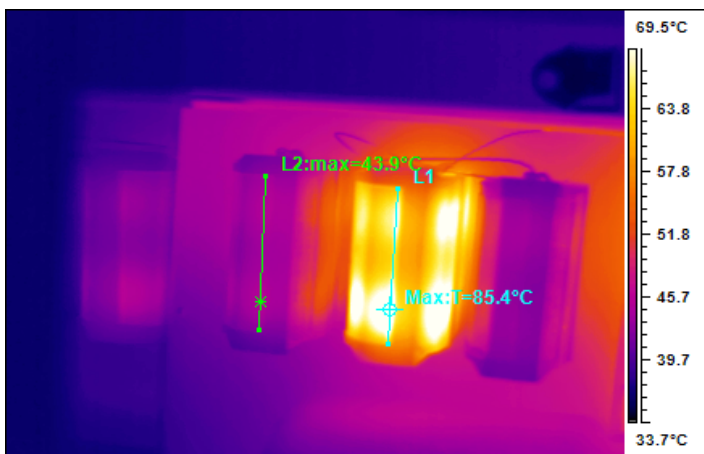
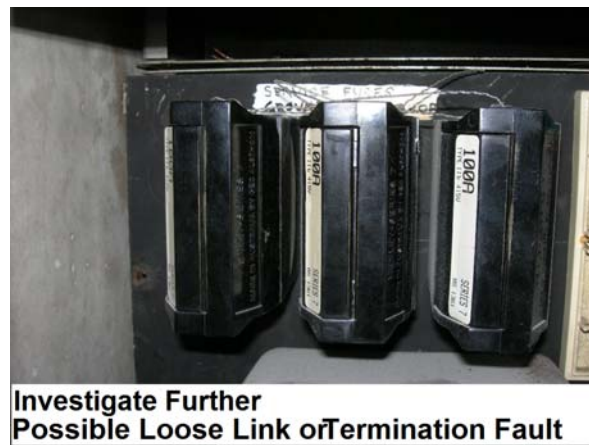
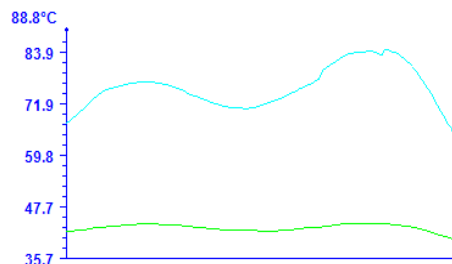
Infrared Image IR005492.JPG

Asset	34 XXX St, Parramatta
Location	Level 1
Switchboard Name	Meter Section
Equipment	100 Amp 3Ø Fuse Link and Base – Service Fuse Ground Level Shop
Fault Description	Internal Termination Fault or Loose Fuse Link. (Note temperature difference at line and load side). Circuitry appears overloaded – see note below.
Working Conditions	Normal
Background Temp	25.0°C
Distance	3.0m
Create Time	Thursday, April 15, 2010

Object Parameter	Value
Max	85.4°C
L1:AvgTemp	77.1°C
L1:MaxTemp	84.5°C
L1:MinTemp	62.3°C
L2:AvgTemp	43.9°C
L2:MaxTemp	43.9°C
L2:MinTemp	40.2°C

Fault Rating	<b>Serious Fault - High</b>
Recommendation or Comment	<p>Repair in 2 to 3 weeks.                  Current was not measured due to space restrictions, so a full assessment could not be reached. Current must be measured to fully assess circuitry.                  If current exceeds Fuse rated capacity – replace Fuse and upgrade the circuit accordingly. If current is less than 100 amps then re-terminate both line and load side and reassess.  <b>Note:</b> Oxidation and arcing damage may have occurred at these temperatures. If oxidation and arcing damage cannot be corrected, parts and cable should be replaced.  <b>Note: Equipment is beyond recommended temperature rise limits.</b></p>

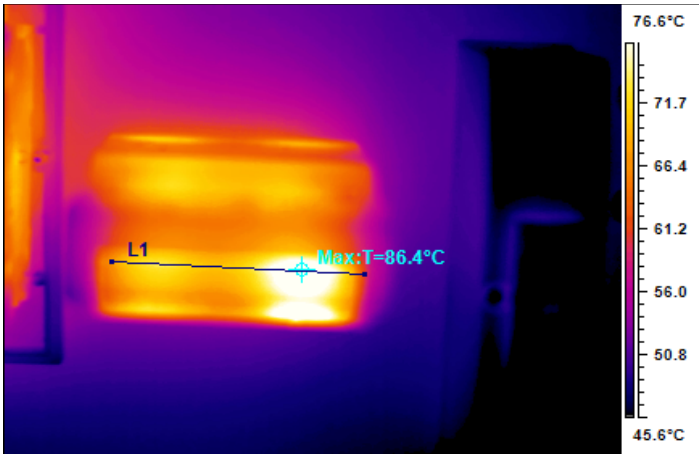
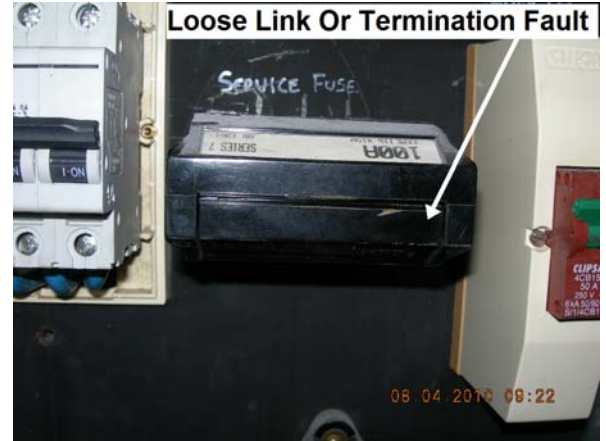
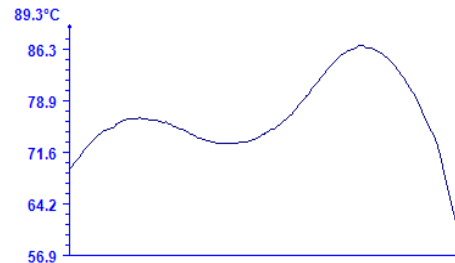
Infrared Image IR005493.JPG

Asset	34 XXX St, Parramatta
Location	Level 1
Switchboard Name	Meter Section
Equipment	100 Amp Fuse Link and Base – Service Fuse
Fault Description	Termination Fault or Loose Fuse Link
Working Conditions	Normal
Background Temp	25.0°C
Distance	3.0m
Create Time	Thursday, April 15, 2010

Object Parameter	Value
Max	86.4°C
L1:AvgTemp	78.2°C
L1:MaxTemp	86.7°C
L1:MinTemp	59.6°C

Fault Rating	<b>Serious Fault - High</b>
Recommendation or Comment	Repair in 2 to 3 weeks. <b>See Notes above</b>

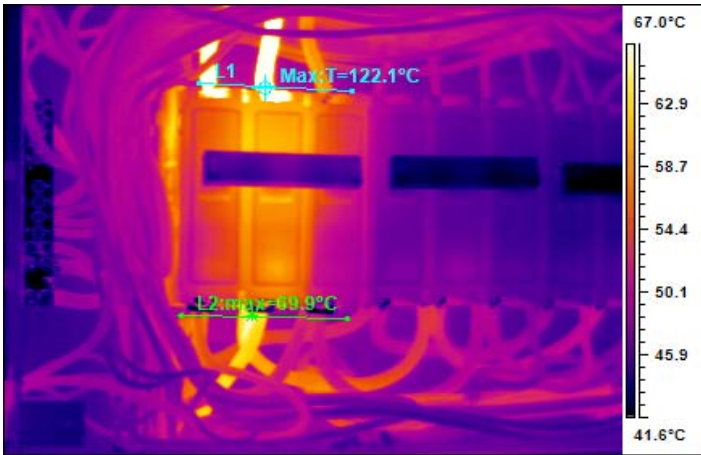
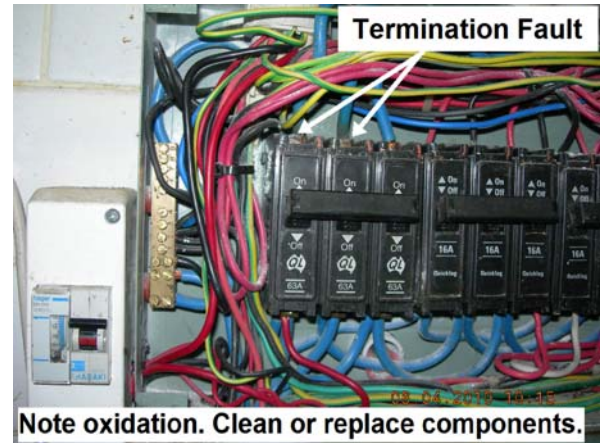
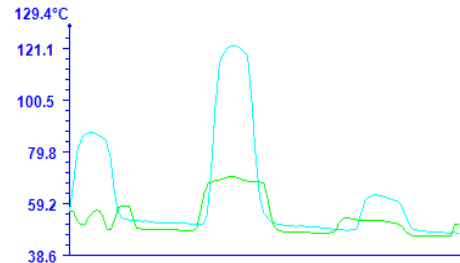
Infrared Image IR005499.JPG

Asset	34 XXX St, Parramatta
Location	Café
Switchboard Name	Distribution Board 1A
Equipment	63 Amp 3Ø Miniature Circuit Breaker (MCB) – CB Mainswitch
Fault Description	Termination Fault
Working Conditions	AØ 7 Amps, BØ 50 Amps, CØ 31.8 Amps Normal
Background Temp	31.5°C
Distance	3.0m
Create Time	Thursday, April 15, 2010

Object Parameter	Value
Max	122.1°C
L1:AvgTemp	65.1°C
L1:MaxTemp	121.9°C
L1:MinTemp	47.5°C
L2:AvgTemp	54.7°C
L2:MaxTemp	69.9°C
L2:MinTemp	46.2°C

Fault Rating	<b>Urgent fault - Extreme</b>
Recommendation or Comment	Requires immediate attention <b>Repair ASAP:</b> Oxidation and arcing damage has occurred at these temperatures. If oxidation and arcing damage cannot be corrected, parts and cable should be replaced
